802124
RADC-TR-66-505
Third Semi-annual Report

FAILURE MECHANISMS IN SEMICONDUCTOR DIODES

TECHNICAL REPORT NO. RADC-TR-66-505

October 1966

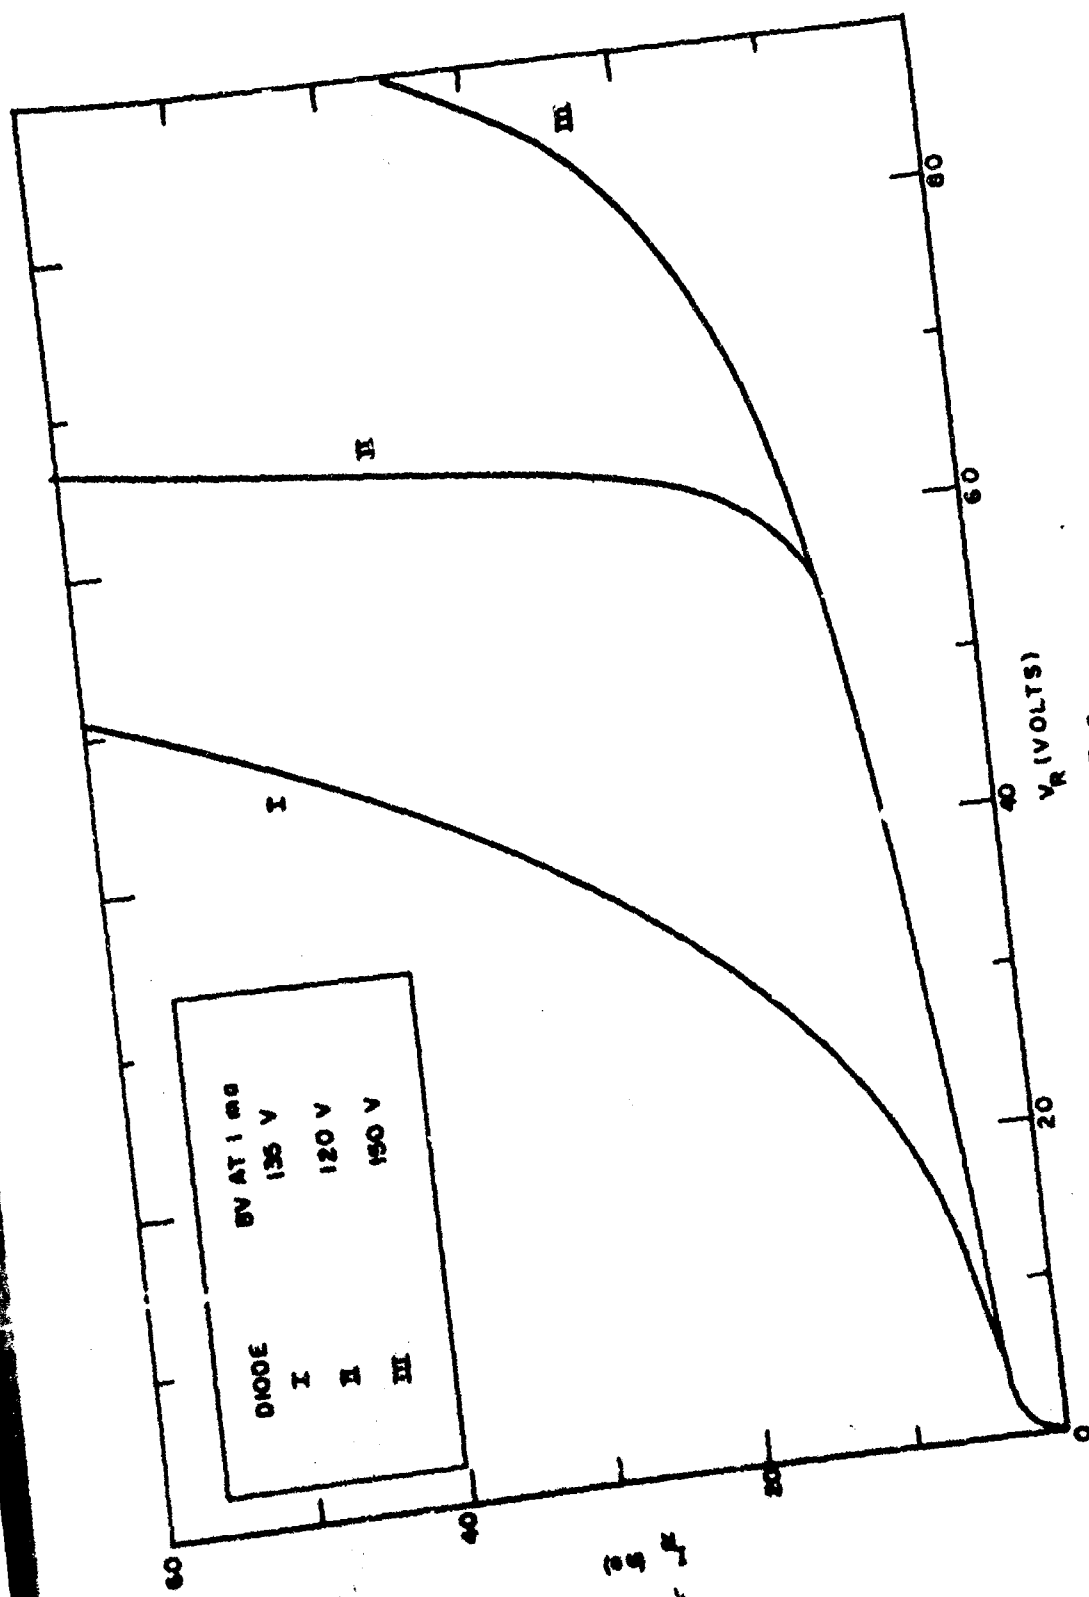
FIGURE 2
REVERSE CHARACTERISTICS OF THREE DIODES

There is an important comparison between characteristics of the unstressed diodes in Figure 2 and those of the degraded units in Figures 3, 4 and 6. It is seen that unit I in Figure 2 had a characteristic which resembled that of an initially harder diode which had undergone a substantial amount of power law degradation. Unit II had a characteristic which resembled those of degraded units which had a rapid current increase above a critical voltage. This was confirmation of the idea that the degradation which accompanied the sealing process, and which necessitated the annealing and aging process, was of the same nature as that observed following forward bias degradation. It also indicated that the annealing and aging process did not completely remove this degradation. This comparison also required that any attempt to calculate the reverse voltage-current characteristics of the unstressed diodes must allow for the presence of an excess current component. This component could not be attributed to uniform or nearly uniform pre-avalanche multiplication in the high field region between the junction and the sub-epitaxial layer, since the breakdown voltage of this region was known to be unaffected by stress.
